## Retrieval of Fractured Abutment Screw and Rehabilitation of Posterior Single Implant Crown with New Prosthesis Using Stock Abutment for Impression: A Case Report

### ABSTRACT

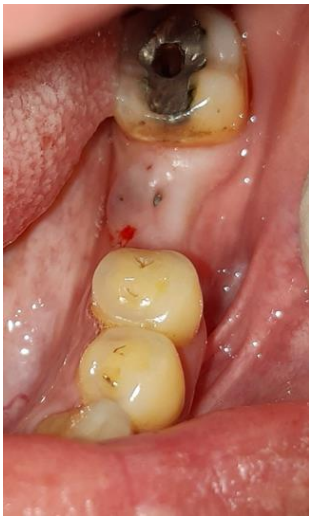
Fig 1: First clinical view.

Examination of prosthesis revealed that it was a cement-retained crown on stock straight abutment with hexagonal connection design. (Fig 1) Intraoral examination revealed soft tissue overgrowth covering the implant access hole partially. This made it unable to check the orientation of prosthesis in the mouth in the same appointment to check the hexagonal connection fit of the existing prosthesis. (Fig 5) close examination of fractured screw revealed the level of fracture was at neck of the screw. The prosthesis design was eccentric with mesial cantilever indication of compromised implant position mesiodistally. The pre retrieval radiograph verified the findings. The IOPA revealed marginal crestal bone loss with distally inclined implant body with a fractured screw at the level of crestal border of the implant. (Fig 3)

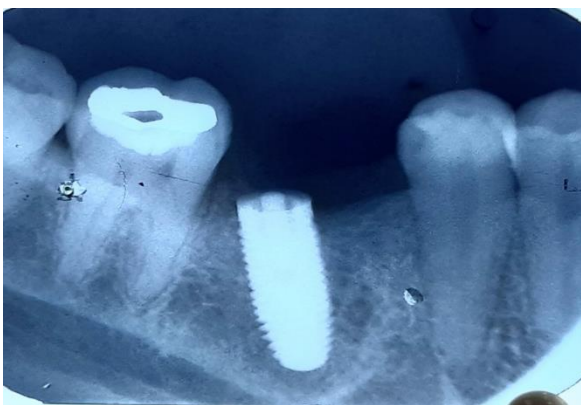
Fig 3: IOPA before retrieval of screw.

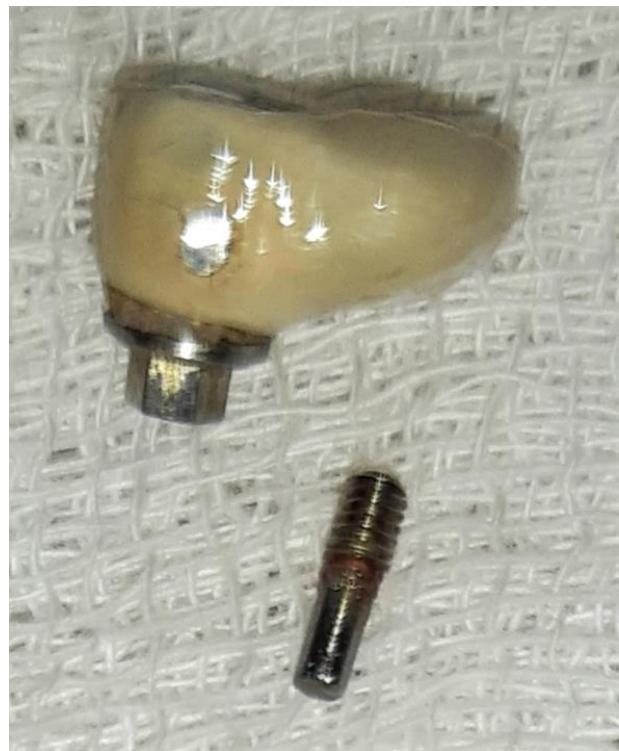
Fig 5: Fractured prosthesis with retrieved screw.

To get the access and visibility of clinical sight, the grown-up tissue was cut using a surgical blade no—15 c under local anaesthesia. Bleeding was controlled with surgical gauze pack. The fractured screw head is easily seen (Fig 2). Attempts were made to remove the screw with the help of a tweezer. As the screw is well torqued, it showed no movement. Few threads of the screw are seen. Use of ultrasonic scaler tip (EMS scaler) in anticlockwise direction with light brush stroke helped to loosen the screw. The loosened screw was carefully picked up with surgical tweezers. Here direction is important as clockwise direction will further tighten the screw. Retrieved screw fragment is thoroughly inspected for signs of thread damage (Fig 5). After screw removal, the inside channel of implant body was flushed with normal saline followed by betadine. After the betadine channel was again thoroughly flushed with normal saline. Then the channel was packed with Teflon tape. Again, a radiograph is recorded for verification of complete retrieval of screw parts. (Fig 4) and margins of peri-implant tissue were trimmed little with round surgical bur with micromotor under copious irrigation of saline. This step was carried out to accommodate flare of the stock gingival former design. After stopping of bleeding gingival former was placed. To check the intactness of thread pattern and shaping of peri implant soft tissue collar healing, gingival former of 3mm height showed satisfactory fitting of the threads and peri implant collar support.

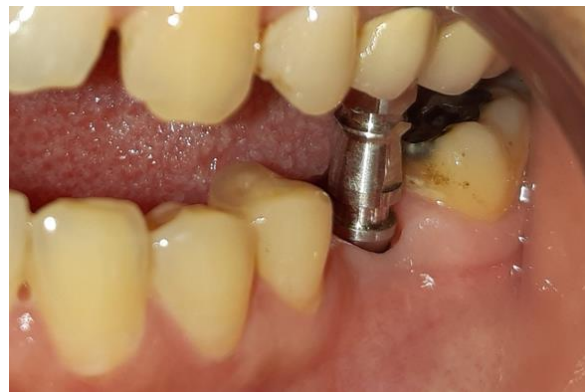
Fig 6: Stock abutment above occlusal level.

After five days of patient-reported for the second clinical visit, the patient decided to go for a similar prosthesis as an old one with stock abutment and cemented crown. The decision was made to make new prosthesis as attempts failed to separate the abutment from the cemented prosthesis. The stock abutment was checked for intraoral fit. It was satisfactory. The height of stock abutment was 5mm above the occlusal level of the mandibular plane. (Fig 6) To cut down cost and record and transfer the true implant orientation, it was decided to use the same abutment for impression-transfer and final abutment. Perforated stock steel tray was modified

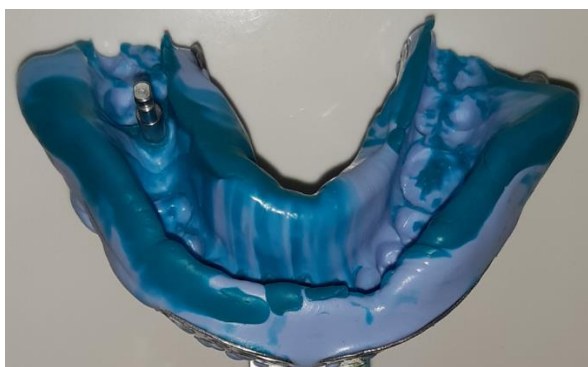
Fig 8: Laboratory analogue in situ with a prosthetic abutment.

with an opening cut in the lower molar region. The fit of abutment was to be verified with radiograph for passive and complete engagement of implant margins as only clinical tightness may give the false fitting impression in supracrestal soft tissue engagement of overgrown alveolar bone. The open-access channel of the prosthetic abutment was blocked with the Teflon tape. Impressions were made with addition silicone one stage impression. Care is taken to keep access hole of abutment open during making an impression and used it as open tray impression analogue. (Fig 7) After retrieval of impression, the laboratory analogue was fixed to impression with hex driver. As laboratory analogue is directly attached to the final prosthetic abutment, errors in transfer from impression are minimised. (Fig 8)

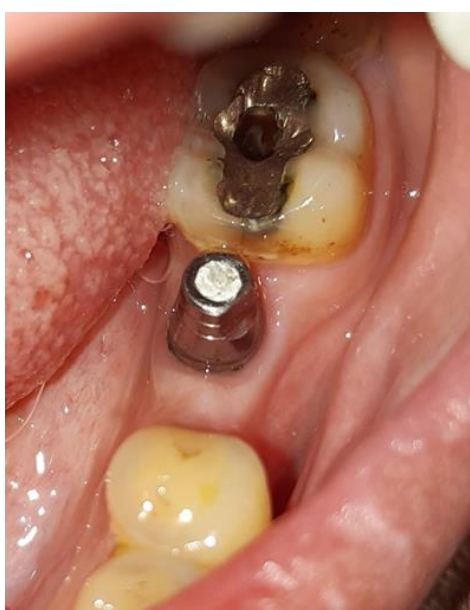
Fig 9: Abutment for occlusal adjustment.

The abutment height was adjusted in lab maintaining sufficient antirational and retentive features for the crown. Minor corrections are done intraorally with functional and non-functional movements avoiding direct occlusal contact on the abutment. A metal-ceramic crown was fabricated. Occlusal adjustments are made. Glaze firing has done prior cementation of this window crown with abutment. Cementation is done extra orally with glass ionomer cement. (Fig 9,10)

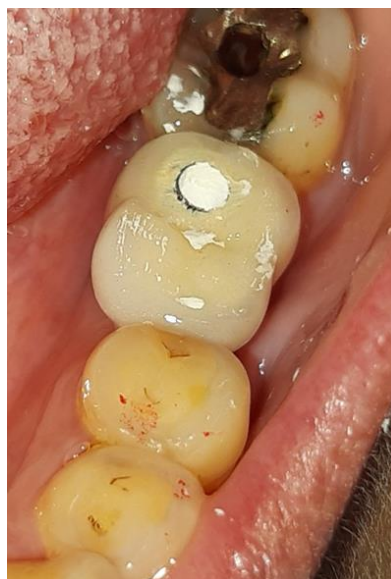
Fig 10: Prosthesis in situ.

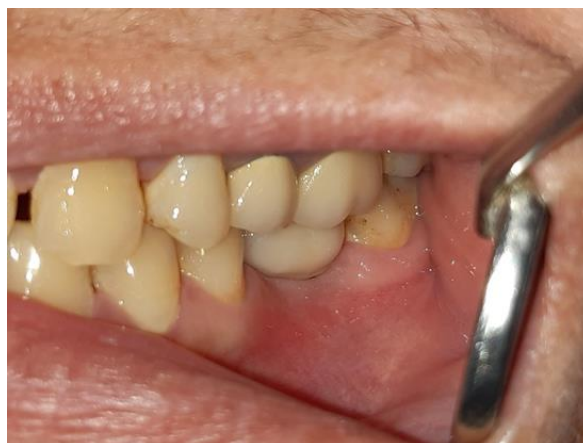
Fig 11: Picture Side view of prosthesis.
