## Broken File Retrieval: Challenge in Endodontics

## CASE REPORT

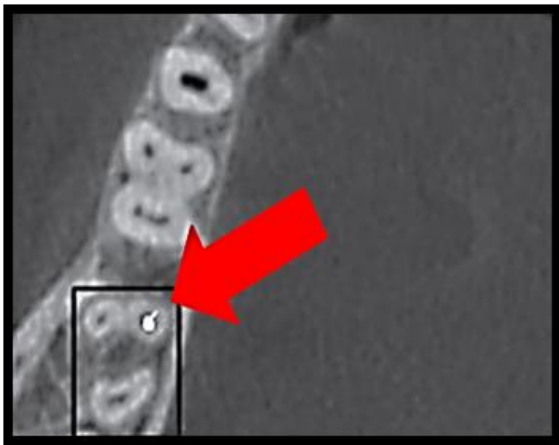
Fig 2: Pre Operative CBCT Image Showing fractured rotary file.

Panineeya Institute of Dental sciences & Research centre with the chief complaint of pain with relation to lower left back tooth region. The patient gave a history of root canal treatment in the lower second molar tooth at a private clinic 6 months back. He was experiencing pain in the same teeth since 3 to 4 months. Clinical examination revealed that there was no associated swelling in relation to the involved teeth but the tooth was tender on percussion. The surrounding gingival tissue appeared inflamed, but the pocked depths were within the normal limits. On taking of RVG (fig 1) it was noted that there was a separated instrument confining the entire length of the mesial canal. Patient was referred for Cone beam computed tomography image of the same to confirm the exact location and position of the fractured file (Fig 2). The results showed the separated instrument within the mesio-lingual canal.

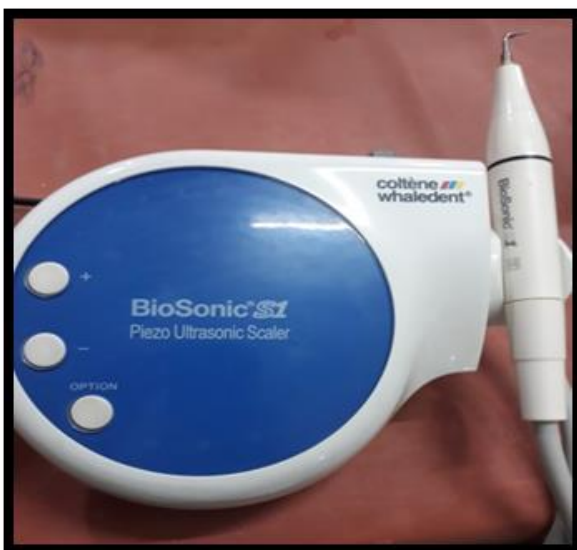
Fig 3: Ultrasonic machine.

The Clinical procedure was started. After rinsing the patient's mouth with 0.2% chlorhexidine solution, local anaesthesia was administered and isolation was done with rubber dam. Access cavity was modified using a safe-end fissure bur (Dentsply) to obtain a straight-line access to the canals. Then, using a modified Gates Glidden drill (size 1, Dentsply), a staging platform was created. This was done to expose the file and the surrounding dentin to allow thinner ultrasonic tips to trough deeper around the file. After staging, ET25 tip of Endo Success™ (Fig 3)

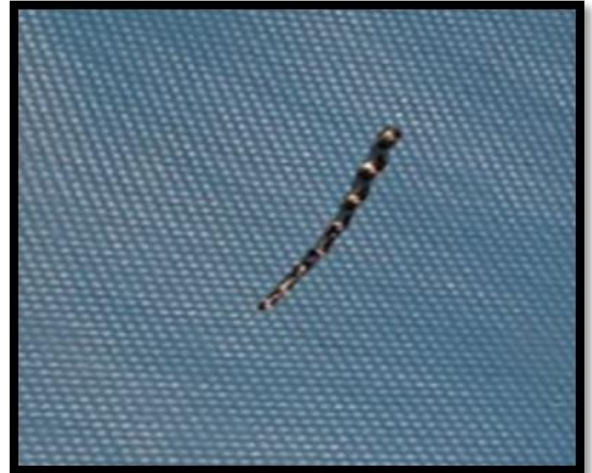
Fig 4: Retrieved fractured rotary file.

advanced only 1mm at a time with copious amount of irrigant (5.25% NaOCL) and after a given insertion if K file comes out of the canal bent or deformed it was discarded. Ultrasonic tips (Pro Ultra ENDO Tips, DENTSPLY Tulsa Dental, Tulsa, Oklahoma)(Fig 2) were used in an Ultrasonic device (Coltene, Whaledent ) (Fig 3) around the fragment to expose it, and then ultrasonic activation with ultrasonic tips were applied to remove the fragment that makes the fragment loosen now the fractured fragment was removed using H file which was approximately 3mm in length. The patency of the canal was checked using magnifying loupes.

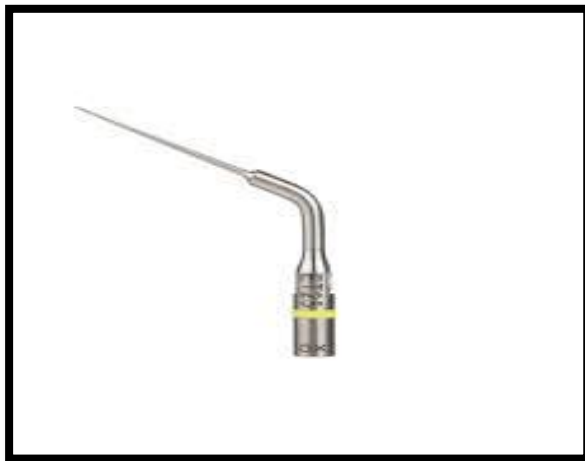
Fig 2: ET 25 ultrasonic tip.

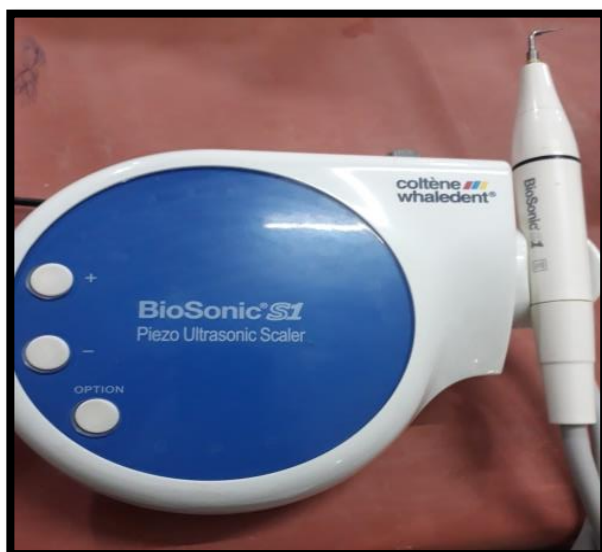
Fig 3: Ultrasonic Machine.

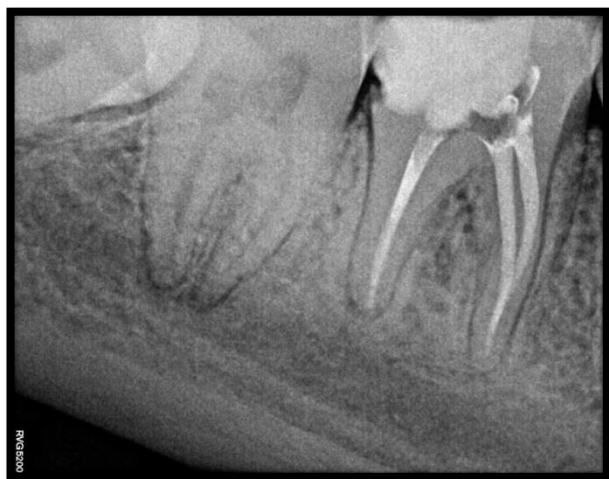
Fig 7: 6 Month follow up image

Multiple radiographs in different angulations were taken; working length was determined using electronic apex locator. Cleaning and shaping were done using WaveOne Gold. Irrigation was performed with 3% sodium hypochlorite solution. Calcium hydroxide paste was used as an intra-canal medicament. Magnifying loupes and ultrasonic's which were used and Clinical image of the retrieved broken instrument. In second appointment, Calcium hydroxide paste was removed using normal saline & Canals were then irrigated with 17% aqueous EDTA solution as a final flush. Root canals were obturated (Fig 5&6) with gutta-percha and AH Plus sealer using warm vertical compaction technique The tooth was subsequently restored. Follow up was done for 6 months and the patient was found to be clinically asymptomatic (Fig 7).
