## Effect of Surface Treatment on Shear Bond Strength of Two Intraoral Porcelain Repair Systems: An In Vitro Study

### ABSTRACT

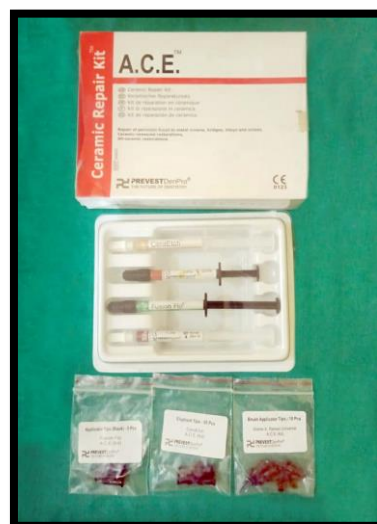
Fig 5: A.C.E Repair System kit

Group I specimens were subjected to A.C.E. porcelain repair system (Figure 5). First of all, metal primer was applied on treated surface to improve the metal-composite bond. After that, 5% hydrofluoric acid etchant was applied for 90s and then rinsed with water and allowed to dry. Silane coupling agent was then applied and allowed to dry for 1 min. After that, bonding agent was applied and polymerized with a light curing unit for 20s. Then, a thin layer of composite was applied to mask the metal and light polymerized for 40s. Additional composite resin was applied till the level of ceramic surface and light polymerized for 40s followed by finishing of the repaired surface (Figure 6).

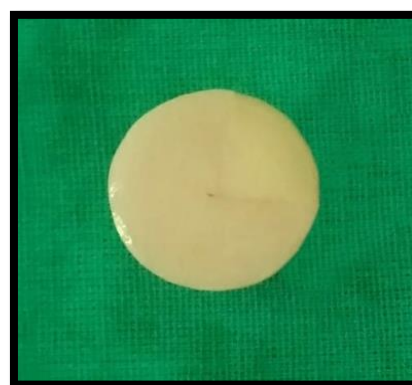
Fig 6: A.C.E repair system application

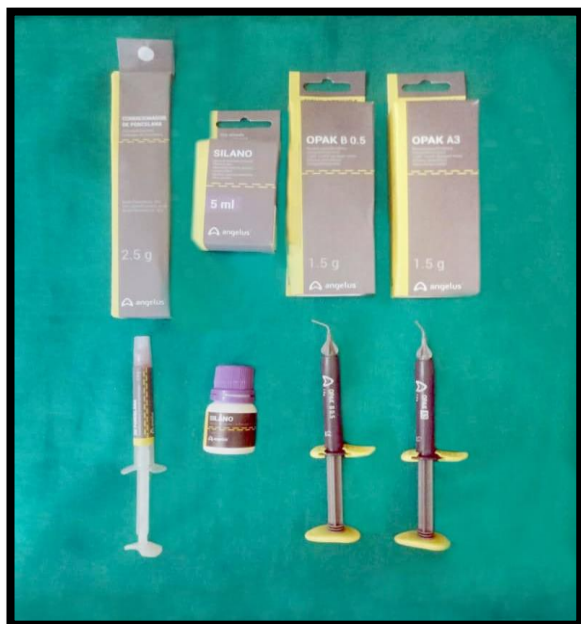
Fig 7: Angelus Repair System kit.

Group II specimens were subjected to Angelus porcelain repair system (Figure 7). First of all, metal primer was applied on the treated surface. This was followed by 10% hydrofluoric acid etchant gel, which was applied for 1 min, then washed abundantly with water, and dried thoroughly. Silane coupling agent was then applied for 1 min and dried. Next, the bonding agent was applied and after air drying, the surface was polymerized with a light curing unit for 10s. Then, a thin layer of composite was applied and light polymerized for 40s. Additional composite resin was applied till the level of ceramic surface and polymerized for 40s followed by finishing of the repaired surface (Figure 8).

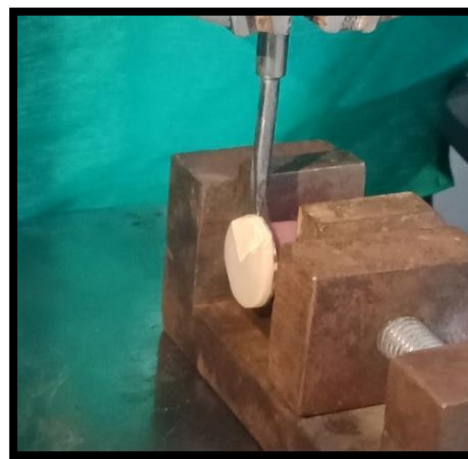
The repaired samples were then stored in distilled water at 37°C for a week before being subjected to a shear load using Universal Testing Machine with a 10 KN load cell at a crosshead speed of 0.5mm/min. Each sample was held in a metal jig for shear bond testing. A chisel load applicator was used to direct a parallel shearing force as close as possible to the metal/repair material interface (Figure 9). The fracture load values for each subgroup were recorded and the type of fracture was observed for each specimen.

Fig 9: Load application for shear bond testing
