## Management of Separated Instrument In a Mandibular Second Molar with Apical Periodontitis Using A Non-Surgical Approach: A Case Report

**Background:** Instrument fracture during root canal treatment is an unwanted and frustrating complication. Fracture of endodontic instrument often results from incorrect use or overuse. When a file breaks in the canal, bypassing or removal can be difficult and long term prognosis of the teeth may be compromised. Ultrasound is a favorable technique for removing broken files, although it may result in some complication. Sometimes surgery may be indicated for removal of broken segment. Fractured segment may hinder cleaning and shaping procedures with potential impact on prognosis of treatment. This report presents a specific approach in non-surgical removal of broken file from mesial canal of mandibular second molar which was partially over extended into the periapical lesion. Masserann kit along with gates glidden were used to remove the intracanal broken instrument.

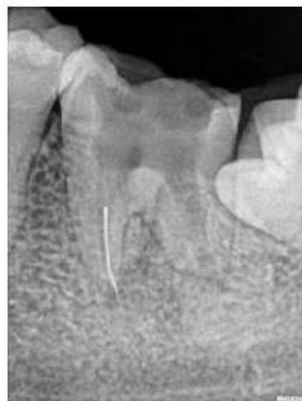
Figure 1

Preoperative Radiograph

A 17 year old female was referred to us with a separated endodontic instrument in mesial canal of mandibular left second molar [37]. On clinical examination, it was found that mandibular left second molar [37] was grossly decayed and access cavity was left opened. Patient complains of a dull throbbing pain with [37] and vitality test of tooth [37] revealed no response. The tooth was tender on percussion. On radiographic examination, a separated instrument was found in middle third of mesio lingual canal (figure 1). Patient was informed about the instrument separation and removal of fragment was planned.

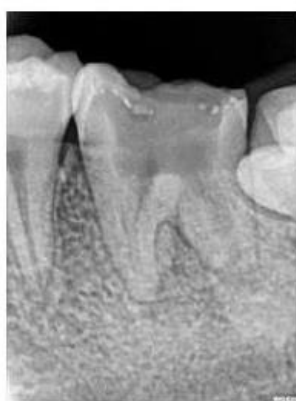
Figure 2

Radiograph after Fragment removal

Masserann kit (micro-mega, Besancon, France) was used to retrieve the instrument. Initially gates glidden drill were used to cut a circumferential trough around a fragment. The metal tube was then fitted over 'freed' end of the fragment, to engage by it means of central stylus that was screwed in position. The instrument was then removed from the canal (figure 2-3).

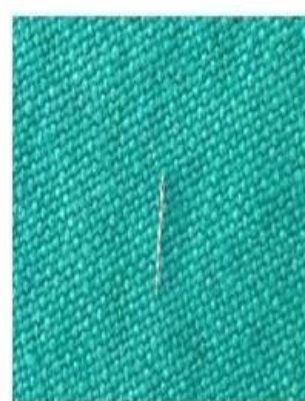
Figure 3

Separated instrument removed

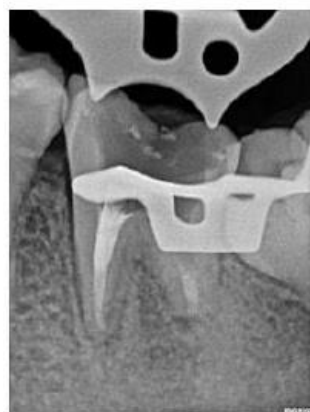
Figure 4

MTA placed in Distal Canal

preparation technique. Copious irrigation with 3% sodium hypochlorite was carried out. After irrigation with normal saline, final rinse was performed using 2% chlorhexidine gluconate. White ProRoot MTA (Dentsply, Tulsa) was mixed with distilled water according to manufacturer's instructions and was placed into the distal canal with fine tipped hand plugger (figure 4). MTA placement continues till its thickness reached almost 5mm. Back filling of the canal was done with thermafil obturation technique (figure 5). Both the mesial canals were obturated using 2% gutta percha cones and AH plus sealer with lateral condensation technique (figure 6). Access cavity was then sealed using hybrid composite (3M, ESPE). Patient was referred to the department of prosthodontics for final restoration.

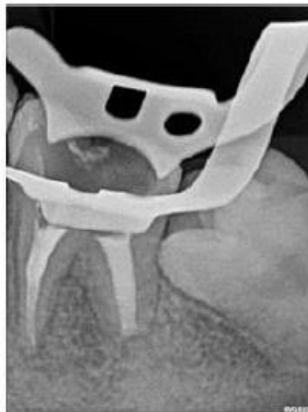
Figure 5

Thermafil Obturation

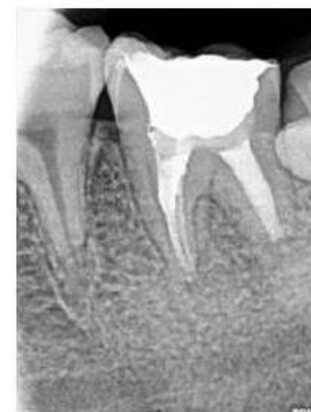
Figure 6

post-obturation Radiograph
